**Fatal Incident
Jack Ryan Drill Ship
August 5th 2010**

Incident Report

No. IR210001

Transocean Crane Load Testing Causes Catastrophic Failure

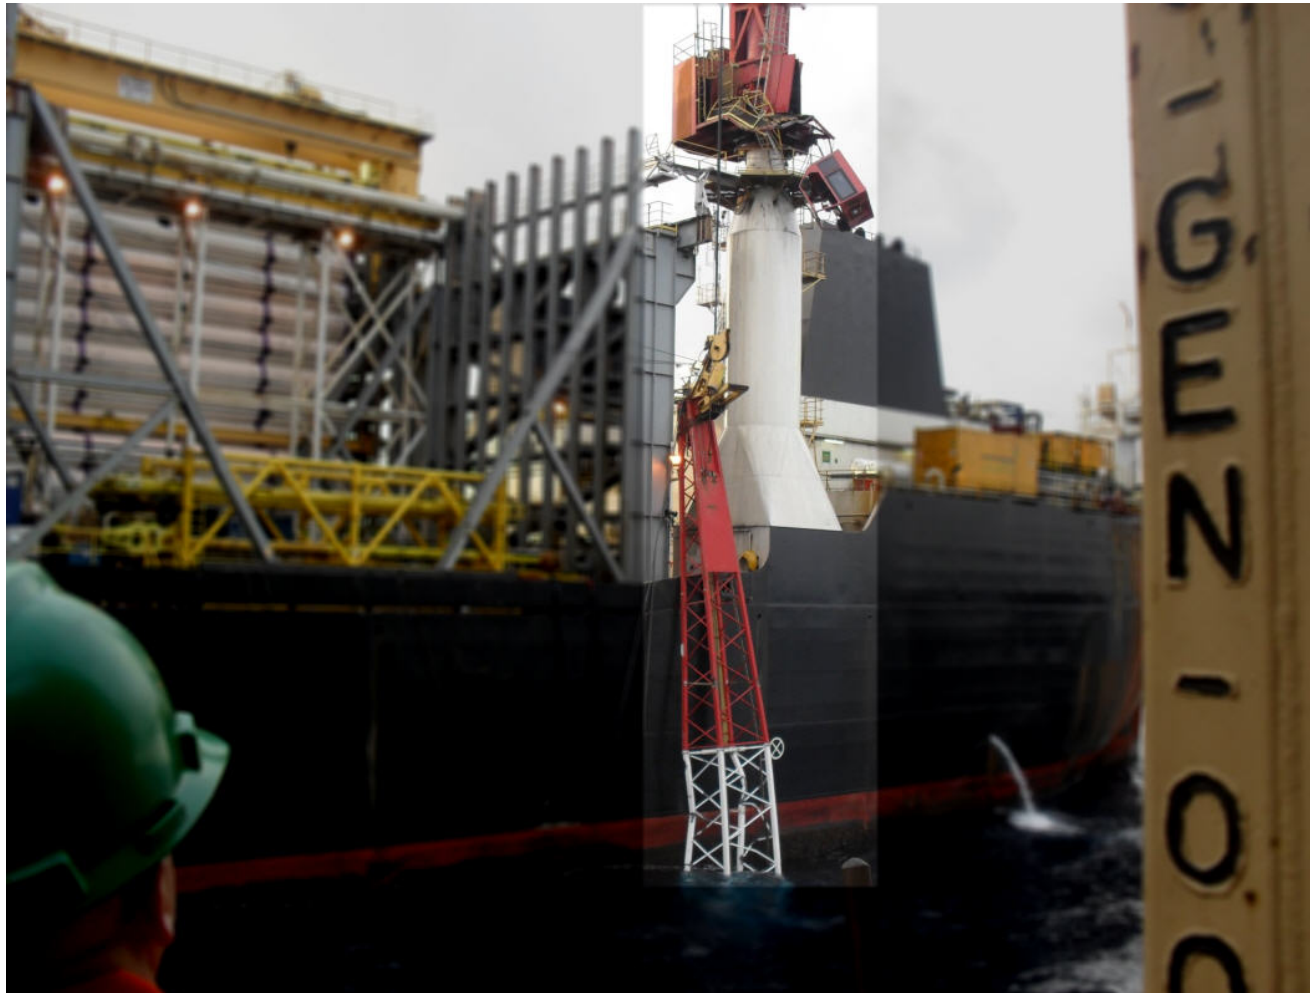
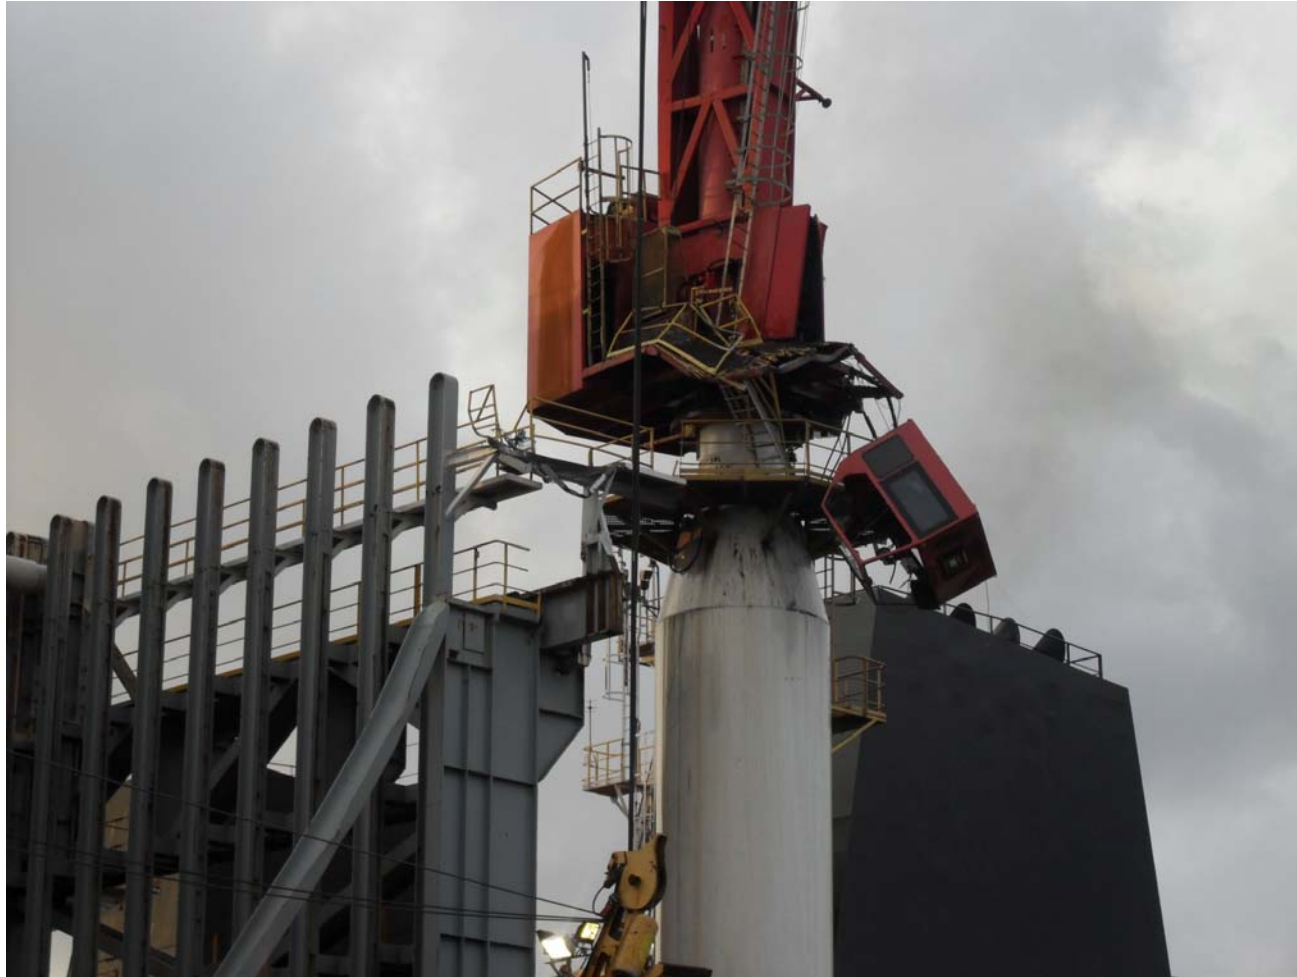
- Load test on the port aft crane
- Crane Operator and Electrical Technician thrown from cab 100ft into sea
- Person supervising the lift also fell into sea and was later confirmed as a fatality

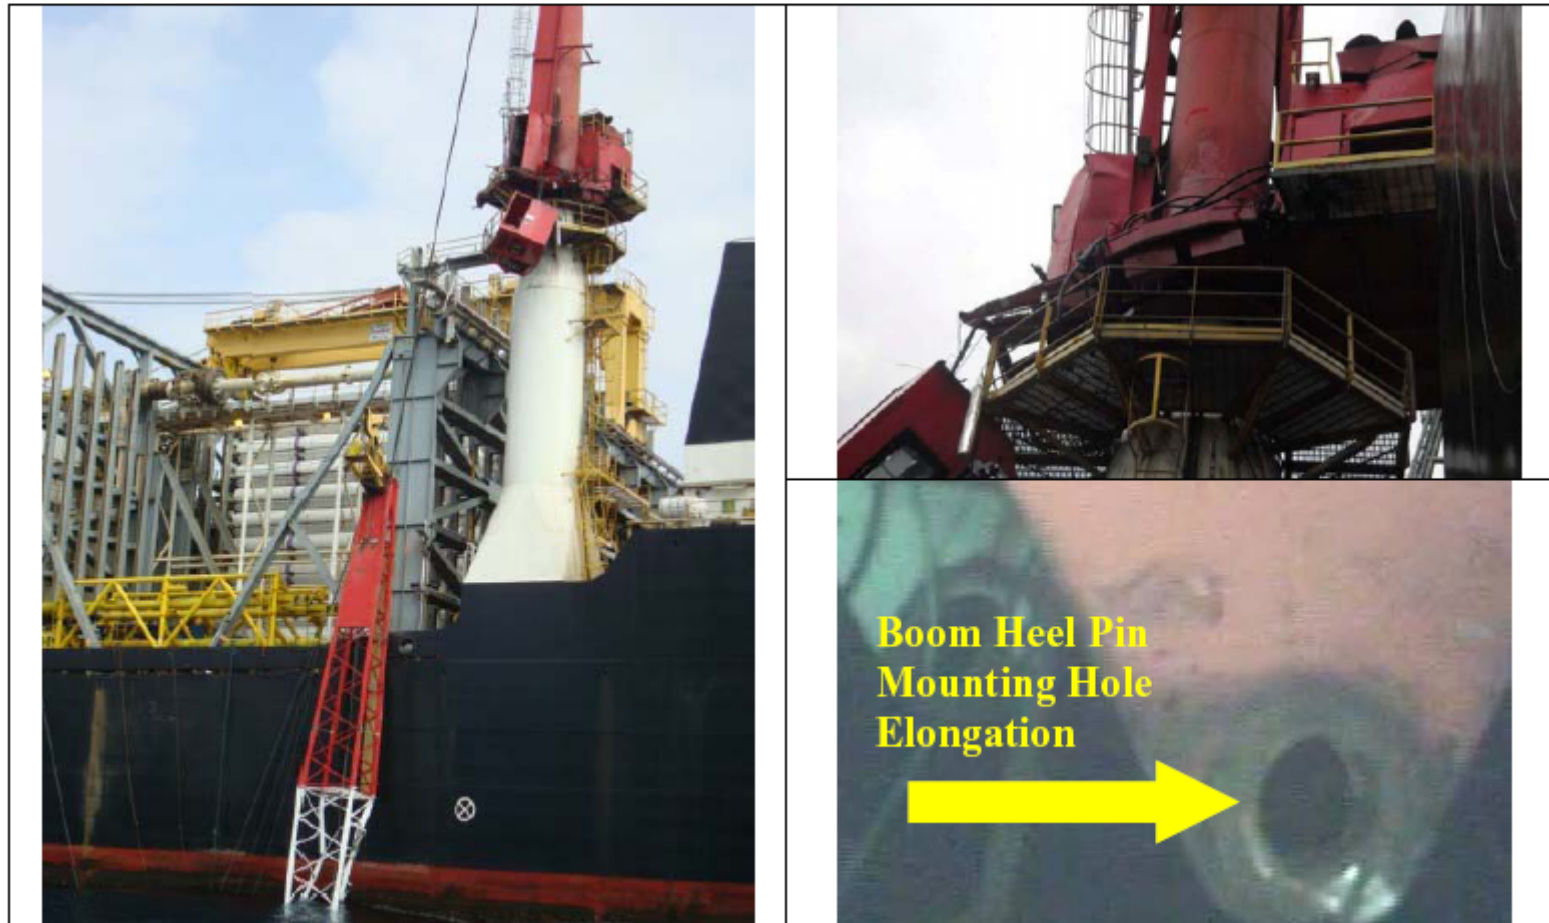
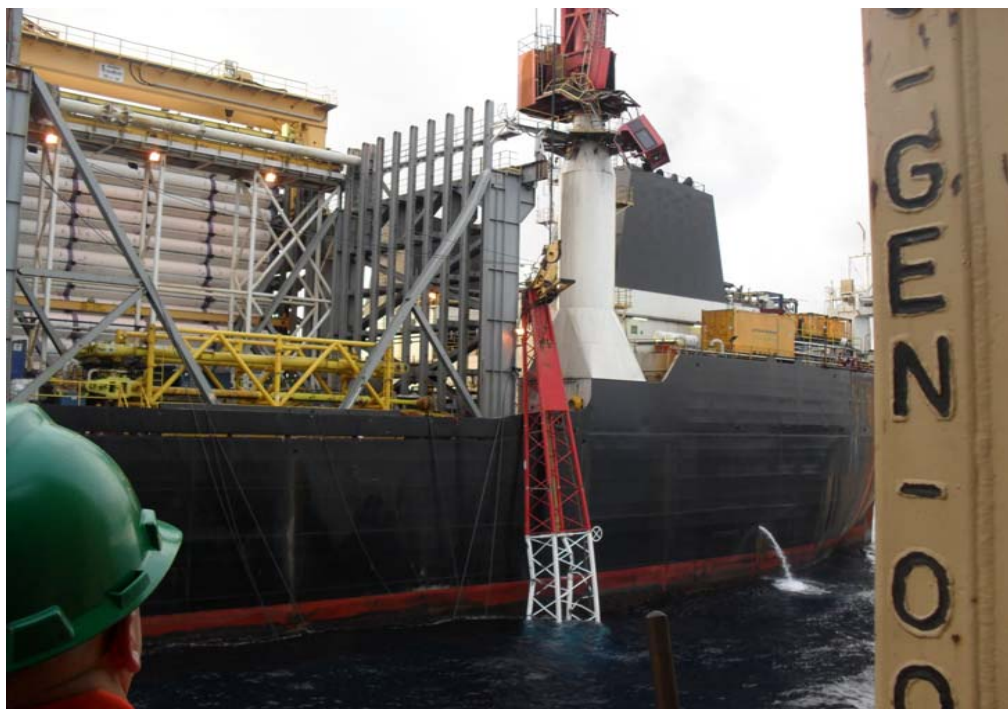
During a crane load test on the Transocean drillship Jack Ryan, using water bags for the load, the crane boom dislodged from the crane upper works. The crane boom came to rest behind the crane in the sea below the drillship. The boom suspension still held the tip section of the boom to the crane. The water bags and the complete boom assembly rested alongside the hull of the ship in the sea below the vessel.

The crane boom impact to the crane cab caused the crane cab to dislodge from the upper works, allowing the operator and another person to be thrown from the crane cab to the sea below.

A history of poor maintenance of the crane allowed for boom heel pin to upper works connection to degrade into an unsafe condition. The boom heel pin bushings were no longer in place, which caused significant wear to the boom heel pins and massive elongation of the boom heel section connection holes. The total amount of wear allowed for movement of the boom tip of eight feet in a side-to-side direction.

The poor maintenance of the boom to upper works connection allowed for a massive side load to be introduced to the crane boom. In addition to the status of the poor connection, the vessel motions induced by the movement of the test load caused the heel pin to upper works connection to fail.

A pre-load test inspection, had one been performed, would have identified these deficiencies.

Perform routine maintenance as described in operations and maintenance manuals which is in accordance with inspection and maintenance criteria outlined in API RP 2D.

When performing a load test, a pre-load test inspection and a post-load test inspection should be performed as described by regulatory recommendations.

A certified calibrated dynamometer should be used when using water bags for load testing to determine the weight of water bags.
