**Fatal Incident
Jack Ryan Drill Ship
August 5th 2010**

Incident Report

No. IR210001

Transocean Crane Load Testing Causes Catastrophic Failure

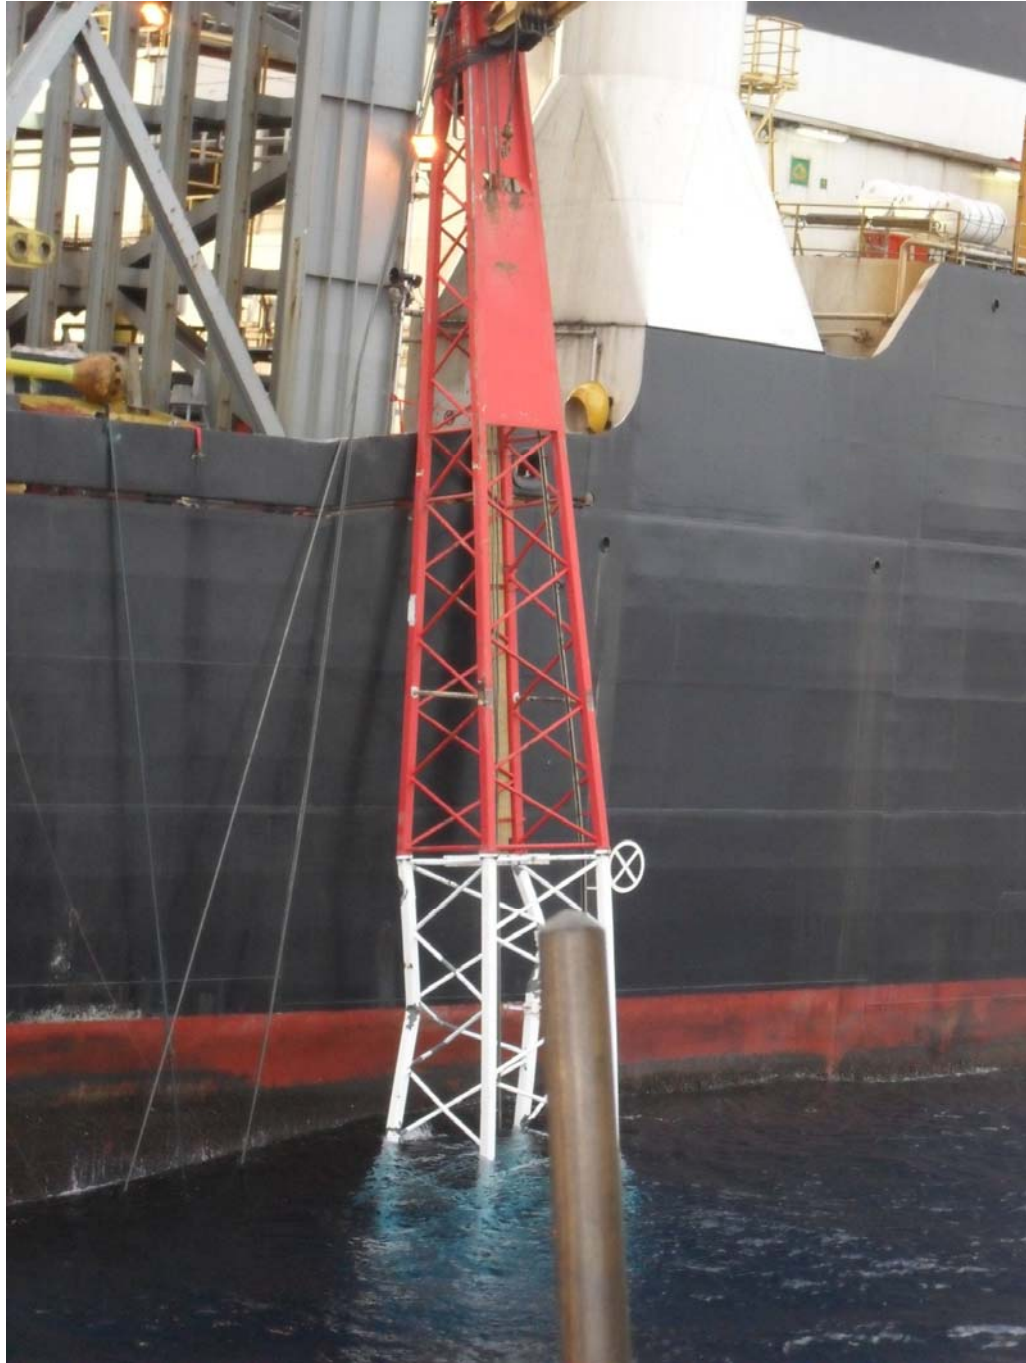
- Load test on the port aft crane
- Crane Operator and Electrical Technician thrown from cab 100ft into sea
- Person supervising the lift also fell into sea and was later confirmed as a fatality

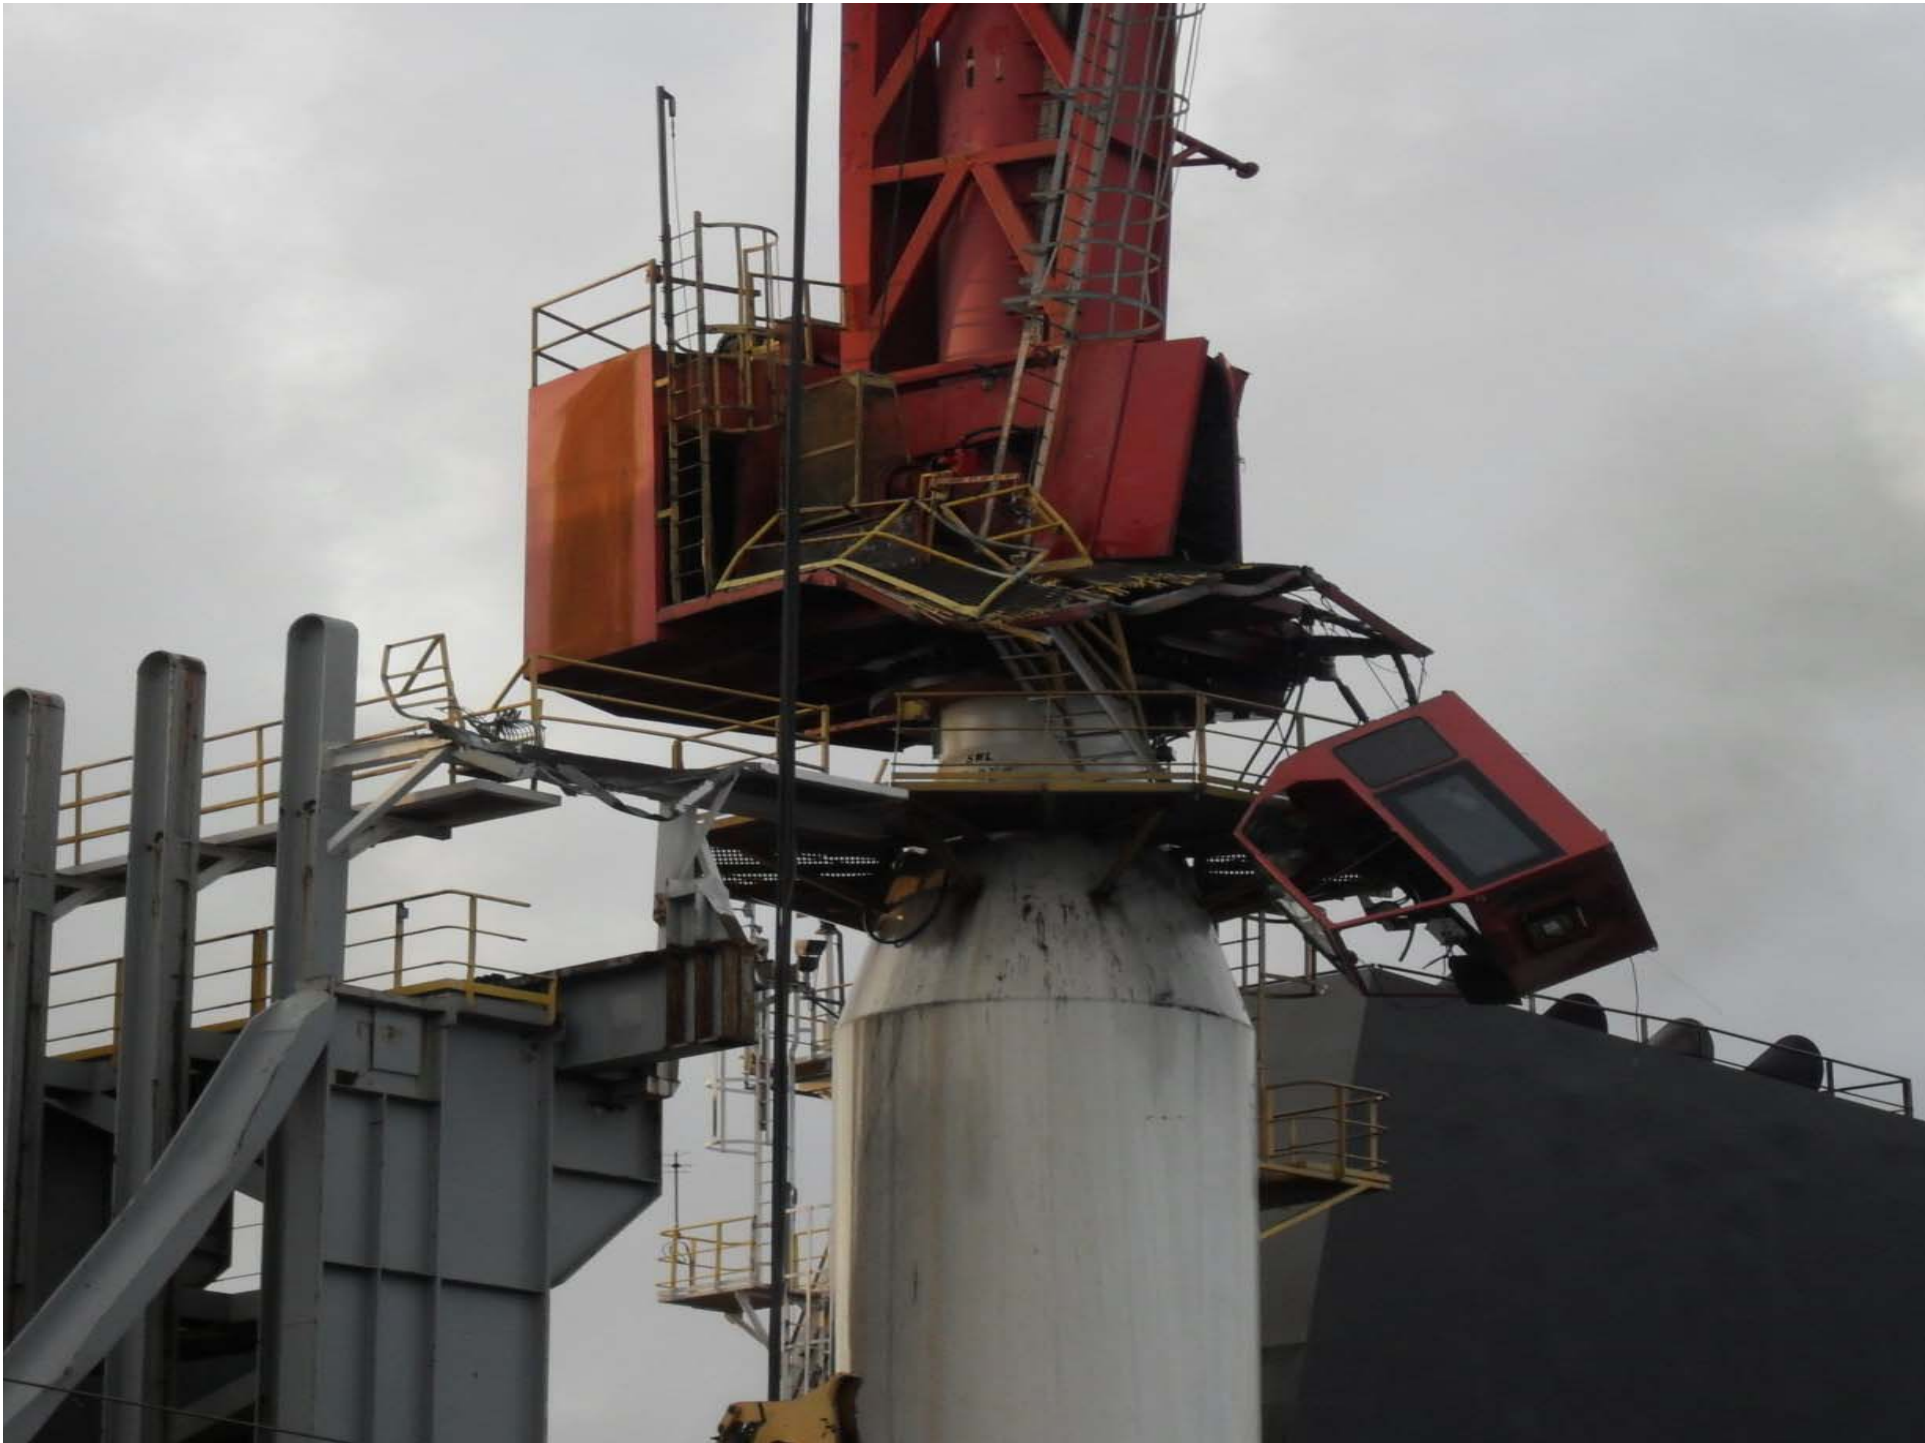
During a crane load test on the Transocean drillship Jack Ryan, using water bags for the load, the crane boom dislodged from the crane upper works. The crane boom came to rest behind the crane in the sea below the drillship. The boom suspension still held the tip section of the boom to the crane. The water bags and the complete boom assembly rested alongside the hull of the ship in the sea below the vessel.

The crane boom impact to the crane cab caused the crane cab to dislodge from the upper works, allowing the operator and another person to be thrown from the crane cab to the sea below.

A history of poor maintenance of the crane allowed for boom heel pin to upper works connection to degrade into an unsafe condition. The boom heel pin bushings were no longer in place, which caused significant wear to the boom heel pins and massive elongation of the boom heel section connection holes. The total amount of wear allowed for movement of the boom tip of eight feet in a side-to-side direction.

The poor maintenance of the boom to upper works connection allowed for a massive side load to be introduced to the crane boom. In addition to the status of the poor connection, the vessel motions induced by the movement of the test load caused the heel pin to upper works connection to fail.

A pre-load test inspection, had one been performed, would have identified these deficiencies.

Perform routine maintenance as described in operations and maintenance manuals which is in accordance with inspection and maintenance criteria outlined in API RP 2D.

When performing a load test, a pre-load test inspection and a post-load test inspection should be performed as described by regulatory recommendations.

A certified calibrated dynamometer should be used when using water bags for load testing to determine the weight of water bags.
